David Lochbaum Director, Nuclear Safety Project

In the middle of May 2011, the Tokyo Electric Power Company (TEPCO) posted information such as scans from paper recorders in the control rooms, computer alarm printouts, parameters plotted from high-speed data recorders (the nuclear equivalent to aircraft black boxes), and operator log books online at <a href="http://www.tepco.co.jp/nu/fukushima-np/index10-j.html">http://www.tepco.co.jp/nu/fukushima-np/index10-j.html</a>.

The available information for Unit 1 stops before the arrival of the tsunami, and well before the point at which fuel in the reactor core was damaged by overheating. Much of the available information ends at 3:17 pm local time, about 30 minutes after the earthquake occurred at 2:46 pm. This available information for the first 30 minutes following the earthquake shows:

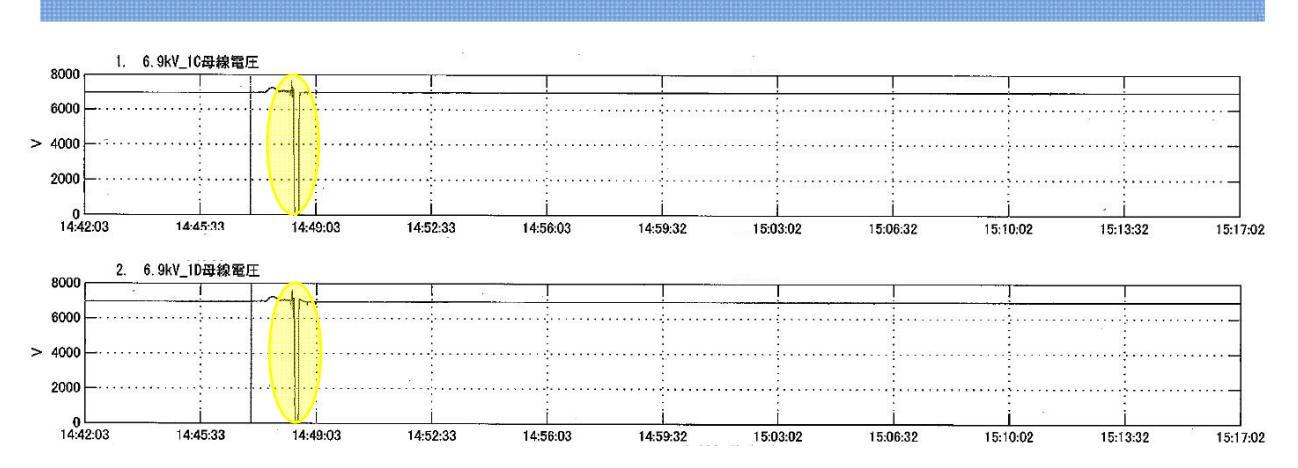
At 51 seconds past 2:47 pm, 6.9 kilovolt bus 1D alarmed on low voltage. A second later, 6.9 kilovolt bus 1C alarmed on low voltage. The normal supplies of power to plant equipment – the output from the Unit 1 generator and the electrical grid – had been lost.

The two charts above show the voltages on 6.9 kilovolt electrical buses 1C and 1D. The plots show the brief power interruptions between the time that the turbine was tripped to stop the supply from the generator's output and the circuit breakers for the emergency diesel generators closed to restore the power supplies.

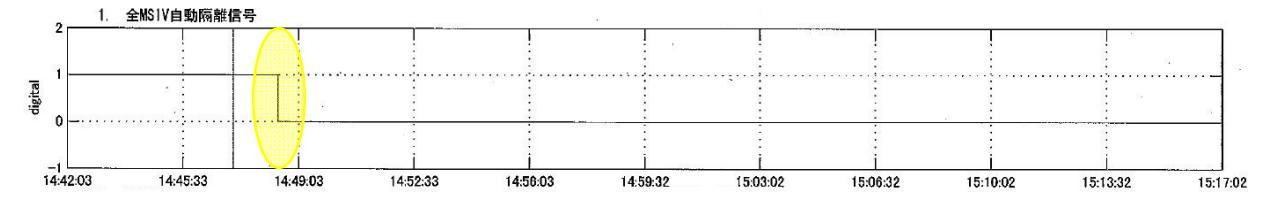
When the MSIVs closed, that steam could no longer travel this path. In addition, the normal supply of makeup water to the reactor vessel to compensate for water leaving as steam is via the feedwater system. The feedwater system features steam-driven pumps. The source of steam for the feedwater pump turbines is taken from the steam lines downstream of the MSIVs. Thus, closure of the MSIVs made the feedwater pumps unavailable.

The chart above shows the digital signal for the MSIVs. A "1" indicates the MSIVs are open while a "0" indicates they are shut. When the power supply was interrupted, the MSIVs automatically closed.

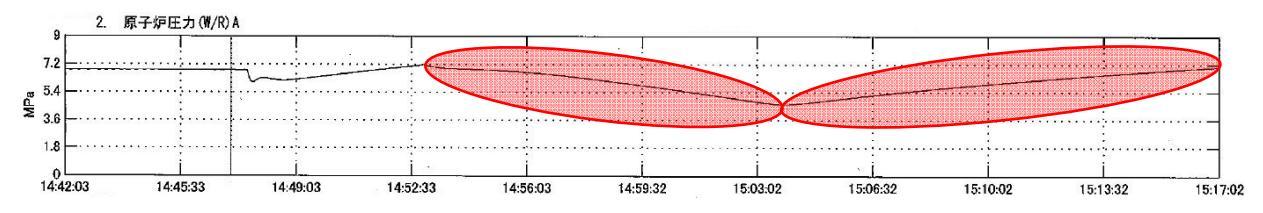
The above chart of pressure inside the reactor vessel over the wider range of 0 to 9 MPa (0 to 1,305 psig) shows that the steadily decreasing pressure trend stopped around 3:04 pm and became a steadily rising pressure trend.

There are reports that the operators took the isolation condenser out of service because the cooldown rate of the reactor was greater than expected or desired. This apparently happened around 3:04 pm.

When the isolation condenser was placed in service around 2:53 pm, the pressure inside the reactor vessel was nearly 7.2 MPa (1,044 psig). This corresponds to a water temperature of nearly 287°C (549°F). When the isolation condenser was removed from service around 3:04 pm, the reactor vessel pressure had dropped to around 4.5 MPa (653 psig). This corresponds to a water temperature of nearly 257°C (494°F). The cooldown rate was approximately 164°C (300°F) per hour (300°F) over those 11 minutes.

The maximum heatup and cooldown rates are established at  $37.8^{\circ}C$  (100°F) per hour. The limit on heatup and cooldown rates are intended to prevent the reactor vessel and attached piping from failing due to stresses caused by expansion and contraction of the metal.

If the isolation condenser was intentionally taken out of service around 3:04 pm due to concerns about excessive cooldown rates, that action merely swapped problems. From 3:04 pm until 3:17 pm, the heatup rate was nearly 138°C (254°F) per hour. An excessive heatup rate is as bad as an excessive cooldown rate. Swapping back and forth between excesses is worse than either excess.

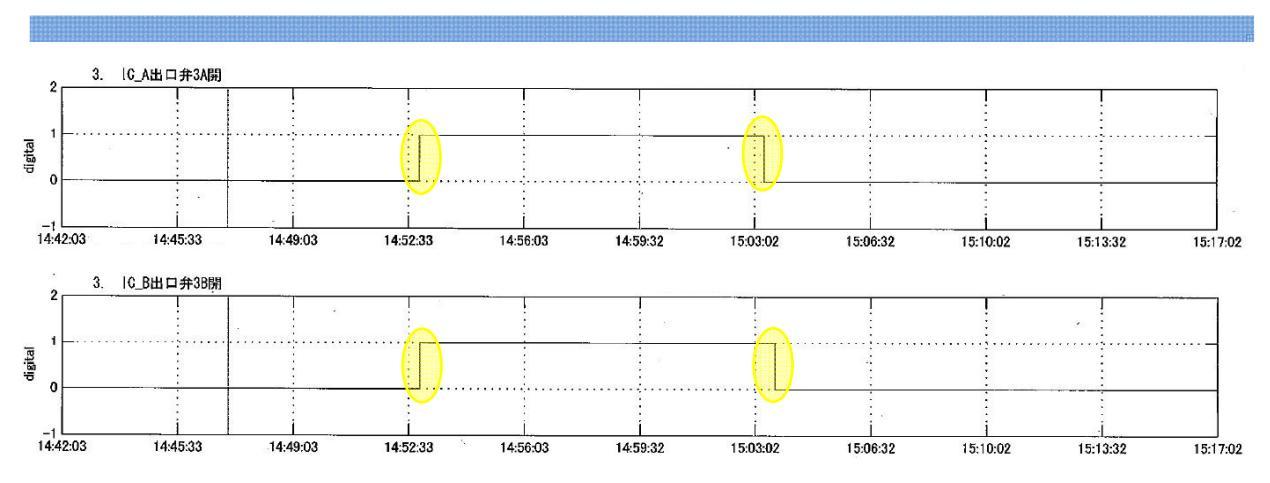
The above two charts show the logic for isolation condensers A and B. The charts show that both isolation condensers were placed in service at the same time around 2:53 pm and that isolation condenser A was taken out of service shortly before isolation condenser B at around 3:04 pm. The concurrent initiation times suggests that both isolation condensers automatically responded to the same sensed condition. The staggered termination times suggests manual action consistent with reported events.

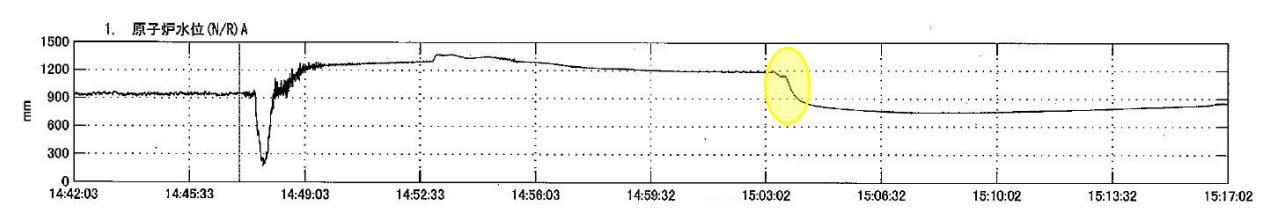
Around 3:04 pm, a significant downward step change in the reactor vessel water level occurred as shown in the chart above. The level dropped from 1,200 millimeters (47.2 inches) to around 800 mm (31.5 inches) in less than a minute. Typically, such downward step changes in water level are explained by:

However, none of these appear to explain the step.

The reactor power level had been zero since 2:47 pm, providing no opportunity for another large, rapid reduction.

The reactor vessel pressure plot on page 8 shows a steadily rising pressure trend, not the kind responsible for downward step changes in reactor vessel water level.

There's no data indicating a source of cold water injection around 3:04 pm. The logic, turbine speed, and flow charts for the high pressure coolant injection system indicate it did not operate during this time period. And the reactor pressure was too high for the core spray and residual heat removal systems to supply water to the reactor vessel. Thus, the emergency core cooling system pumps did not inject cold water into the reactor vessel around 3:04 pm. And as previously discussed on page 6, the closed MSIVs prevented normal makeup flow to the reactor vessel via the feedwater system.

Broken pipes, stuck-open valves, and other explanations for the level drop seem to be contradicted by the fairly steady trend between 3:05 pm and 3:17 pm and the increasing pressure trend over that period shown in the prior chart.

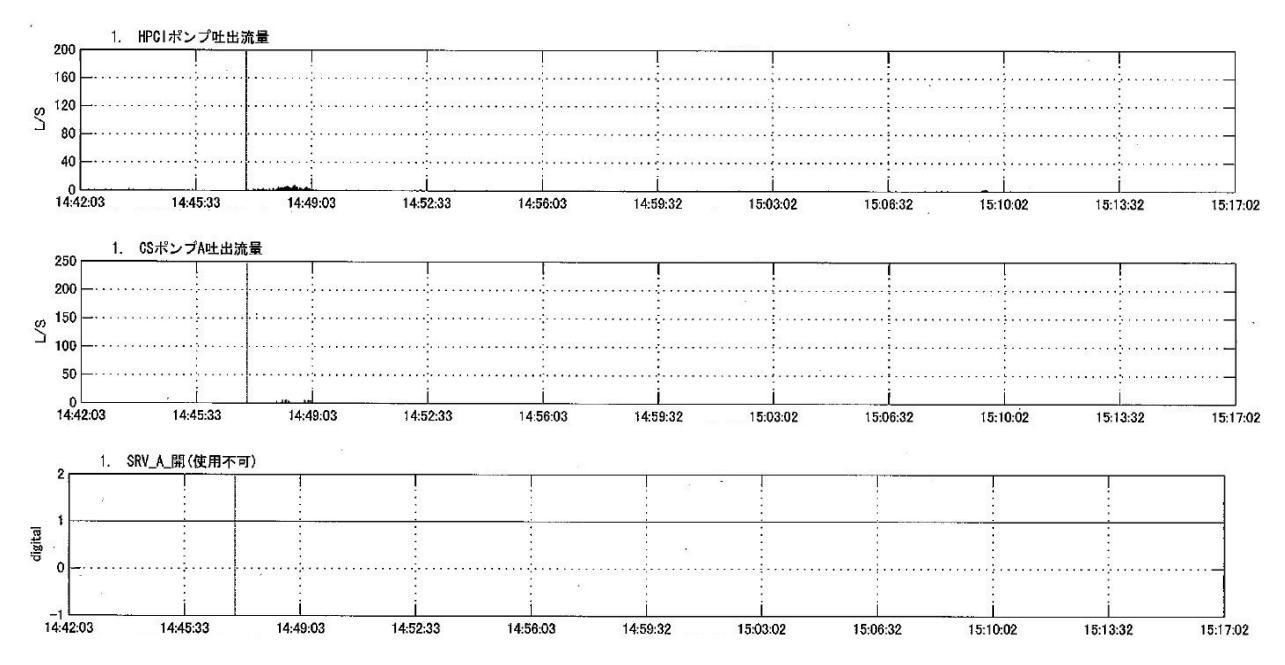
The first two charts above show the flow rates for the high pressure coolant injection (HPCI) and core spray (CS) systems respectively. The third chart shows the open/close logic for one of the safety relief valves (SRV). The other SRV logics show the same thing. Neither HPCI nor core spray injected water during this time period, so their operation cannot account for the downward step change in reactor vessel water level around 3:04 pm. Likewise, the SRVs did not open during this time period and cannot have caused the level drop.
