David Lochbaum Director, Nuclear Safety Project

In the middle of May 2011, the Tokyo Electric Power Company (TEPCO) posted information such as scans from paper recorders in the control rooms, computer alarm printouts, parameters plotted from high-speed data recorders (the nuclear equivalent to aircraft black boxes), and operator log books online at <a href="http://www.tepco.co.jp/nu/fukushima-np/index10-j.html">http://www.tepco.co.jp/nu/fukushima-np/index10-j.html</a>.

The available information for Unit 1 stops before the arrival of the tsunami, and well before the point at which fuel in the reactor core was damaged by overheating. Much of the available information ends at 3:17 pm local time, about 30 minutes after the earthquake occurred at 2:46 pm. This available information for the first 30 minutes following the earthquake shows:

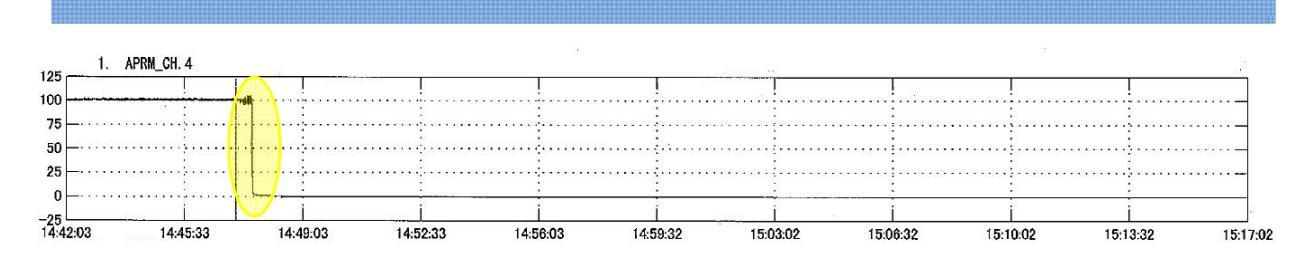
Unit 1 had 88 neutron detectors of the local power range monitoring (LPRM) system installed within the reactor core. There were 22 strings of LPRM detectors at different core locations. Each LPRM string contained 4 LPRM detectors spaced from core bottom to core top. 14 or 15 of the LPRM detector signals from diverse radial and axial core locations were sent to six average power range monitor (APRM) channels. This allowed each APRM channel to monitor overall core power level. Each APRM channel was adjusted to match the percent of rated core thermal power as determined by a mass and energy balance calculation performed by the plant's computer. The APRMs provided real-time, continuous monitoring of the reactor power level and would trigger an automatic shut down if it rose too high.

The chart above provides the output from APRM Channel A. The traces for APRM Channels B through F are similar. In response to the rapid insertion of the control rods, the core power level quickly drops from 100 percent to 0 and remained at 0. The reactor core was shut down shortly after the earthquake struck.

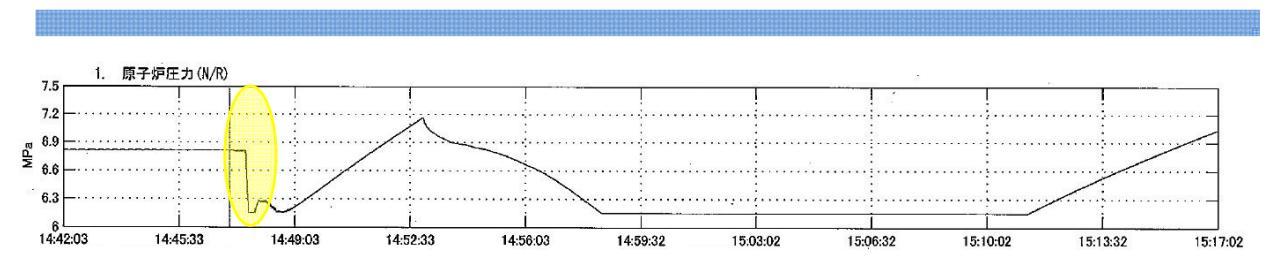
Power, pressure, and water level are the three key parameters to monitor for the reactor core and the reactor vessel. The power level went to zero as control rods rapidly entered the reactor core. The chart above shows the pressure inside the reactor vessel. The pressure had been steady at 6.817 megapascals (MPa, corresponding to 988.7 pounds per square inch gauge, psig) prior to the event. When the control rods rapidly inserted, the ensuing reactor power reduction caused the reactor pressure to decrease to around 6.075 MPa (881.1 psig).

The chart above plots the narrow-range reactor vessel pressure that only monitors pressure down to around 6.15 MPa. The chart of wide-range reactor vessel pressure, which tracks pressure down to 0 MPa, showed the extent of the reactor vessel pressure drop resulting from the reactor shut down.

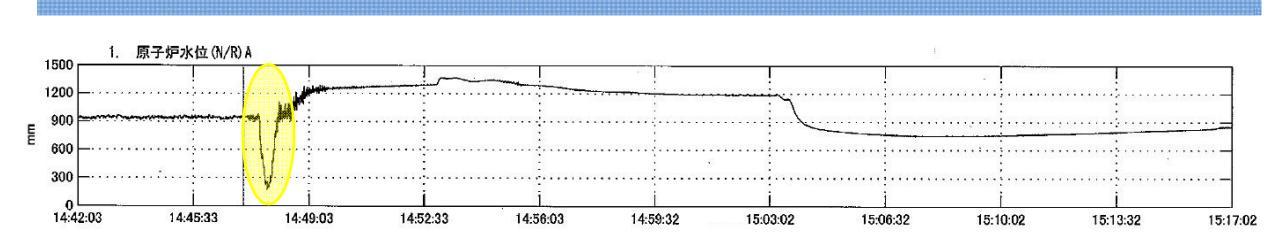
The water level inside the reactor vessel is the third key parameter. The chart above plots the water level over the narrow range of 0 to 1,500 millimeters (mm). The water level had been steady at 949 mm (37.4 inches) prior to the earthquake.

For this instrument, 0 mm corresponds to the bottom of the steam separators while 1,500 mm corresponds to the top of the steam separators. This is comparable to the 0 to 60 inch instrument shown in the schematic to the left. Zero on this scale is 3,940 mm (155 inches or nearly 13 feet) above the top of the reactor core.

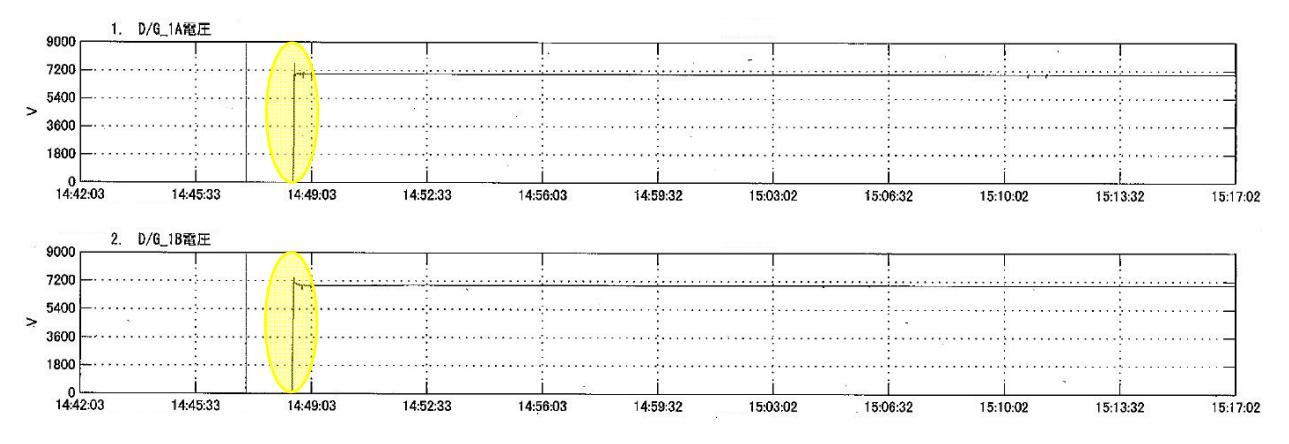
The two charts above show the voltages generated by emergency diesel generators 1A and 1B. These emergency diesel generators automatically started when undervoltage was detected on 6.9 kilovolt buses 1C and 1D and provided backup power when the normal power supplies were lost.

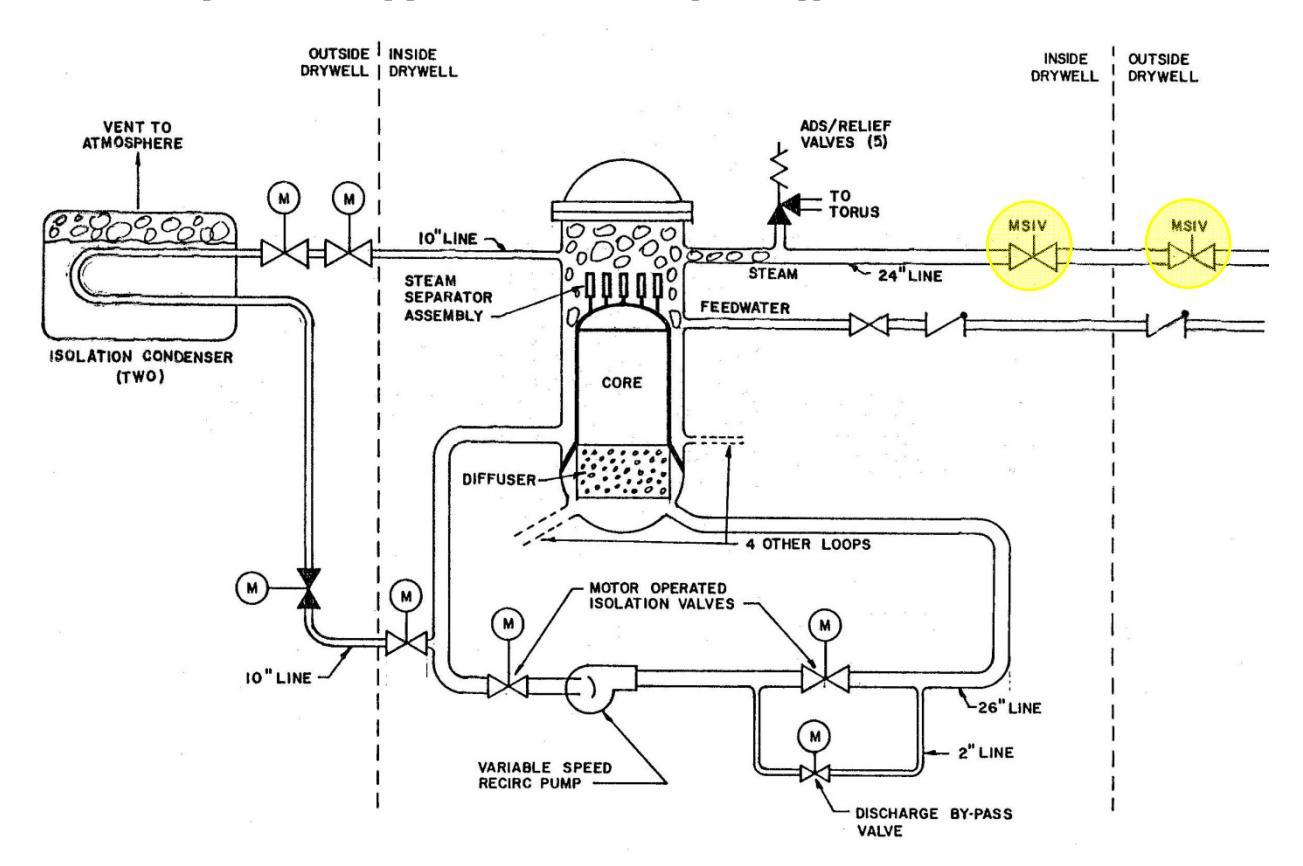
The momentary loss of power closed the main steam isolation valves (MSIVs). As shown in the diagram above, there are two MSIVs in each of the four pipes carrying steam from the reactor vessel to the turbine. The fail-safe position of the MSIVs is closed. When power was lost, the MSIVs closed. Steam being produced by the reactor core's decay heat had been traveling through the steam lines to the turbine.

When the MSIVs closed, that steam could no longer travel this path. In addition, the normal supply of makeup water to the reactor vessel to compensate for water leaving as steam is via the feedwater system. The feedwater system features steam-driven pumps. The source of steam for the feedwater pump turbines is taken from the steam lines downstream of the MSIVs. Thus, closure of the MSIVs made the feedwater pumps unavailable.

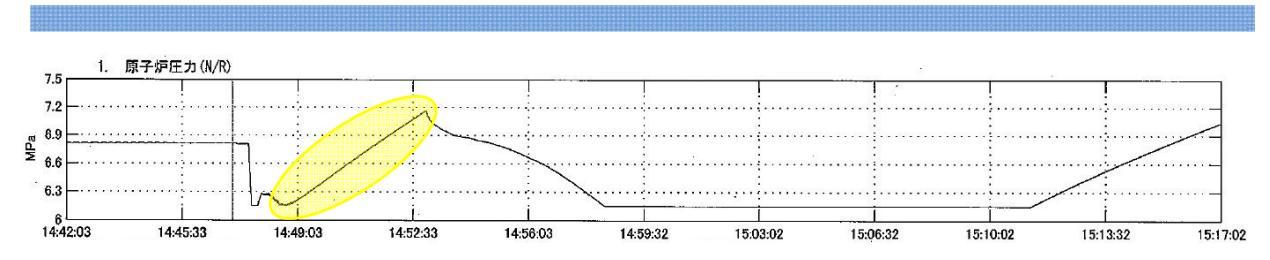
The closure of the MSIVs changed the trend of pressure inside the reactor vessel. Pressure had been trending downward as the amount of steam produced by the reactor core's decay heat was transported through the steam pipes to the turbine. When the MSIVs closed, the steam had no place to go. Bottled up inside the reactor vessel, the continued production of steam caused the reactor vessel pressure to steadily increase for the next five minutes.

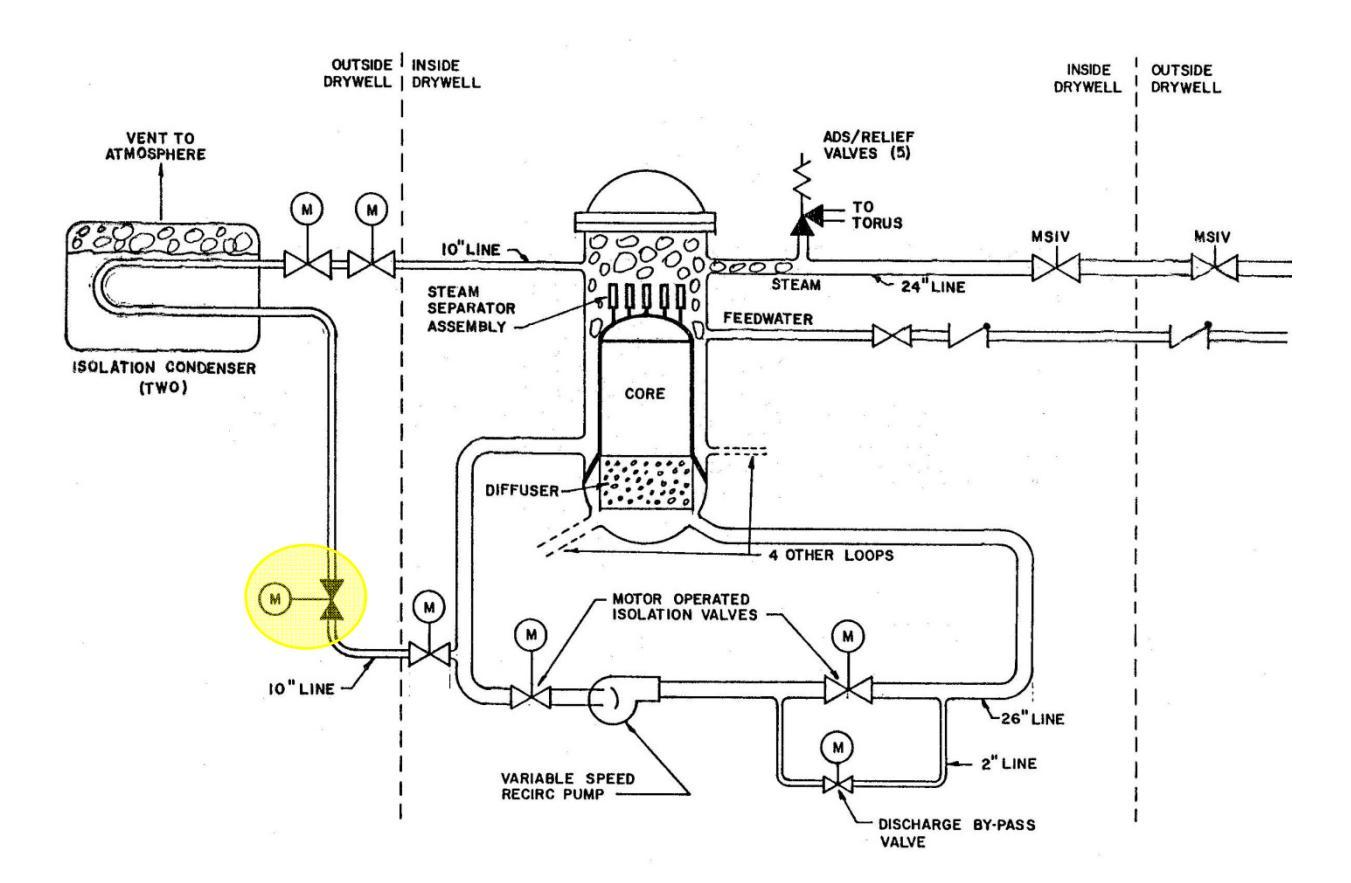
As shown on the left side of the diagram above, the isolation condensers are large tanks of water. Tubes pass through the water-filled tanks. When the two valves opened (one isolation condenser and one valve is shown in the diagram – the valve that opened is represented by the black bowtie shaped symbol (highlighted in yellow) in the drain line from the isolation condenser), steam from the reactor vessel flowed through the isolation condensers' tubes. Heat from the steam passed through the thin metal tube walls to be absorbed by the isolation condensers' water. The steam cooled and condensed back into water. This water drained into the recirculation system piping and was returned to the reactor vessel.

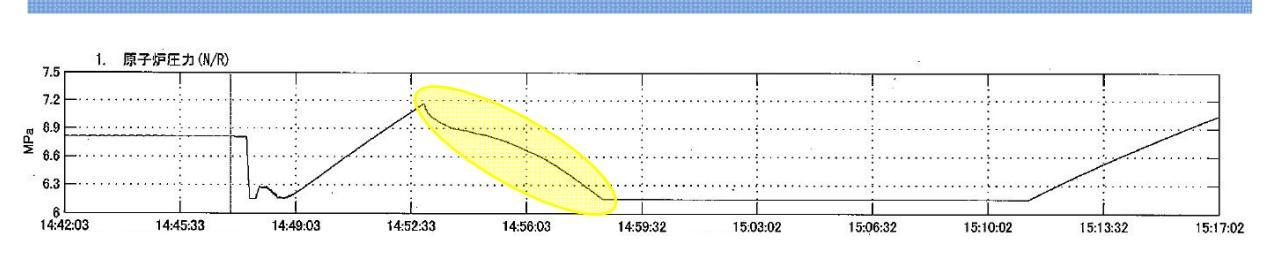
The in-service isolation condenser provided some place for the steam being produced by decay heat in the reactor core to go. Consequently, the steadily rising pressure trend following the MSIV closure was stopped and a steadily decreasing pressure trend begun. The decay heat produced by the reactor core was being used to warm the water inside the isolation condenser instead of pressuring the bottled-up volume inside the reactor vessel.
